Wood Damages and Improvement in Rural Mosques: Ordu Mosque

Şengül YALÇINKAYA ^{1*}

Citation: Yalçinkaya, Ş. (2023). Wood damages and improvement in rural mosques: Ordu Mosque. *Journal of Architectural Sciences and Applications*, 8 (1), 100-111.

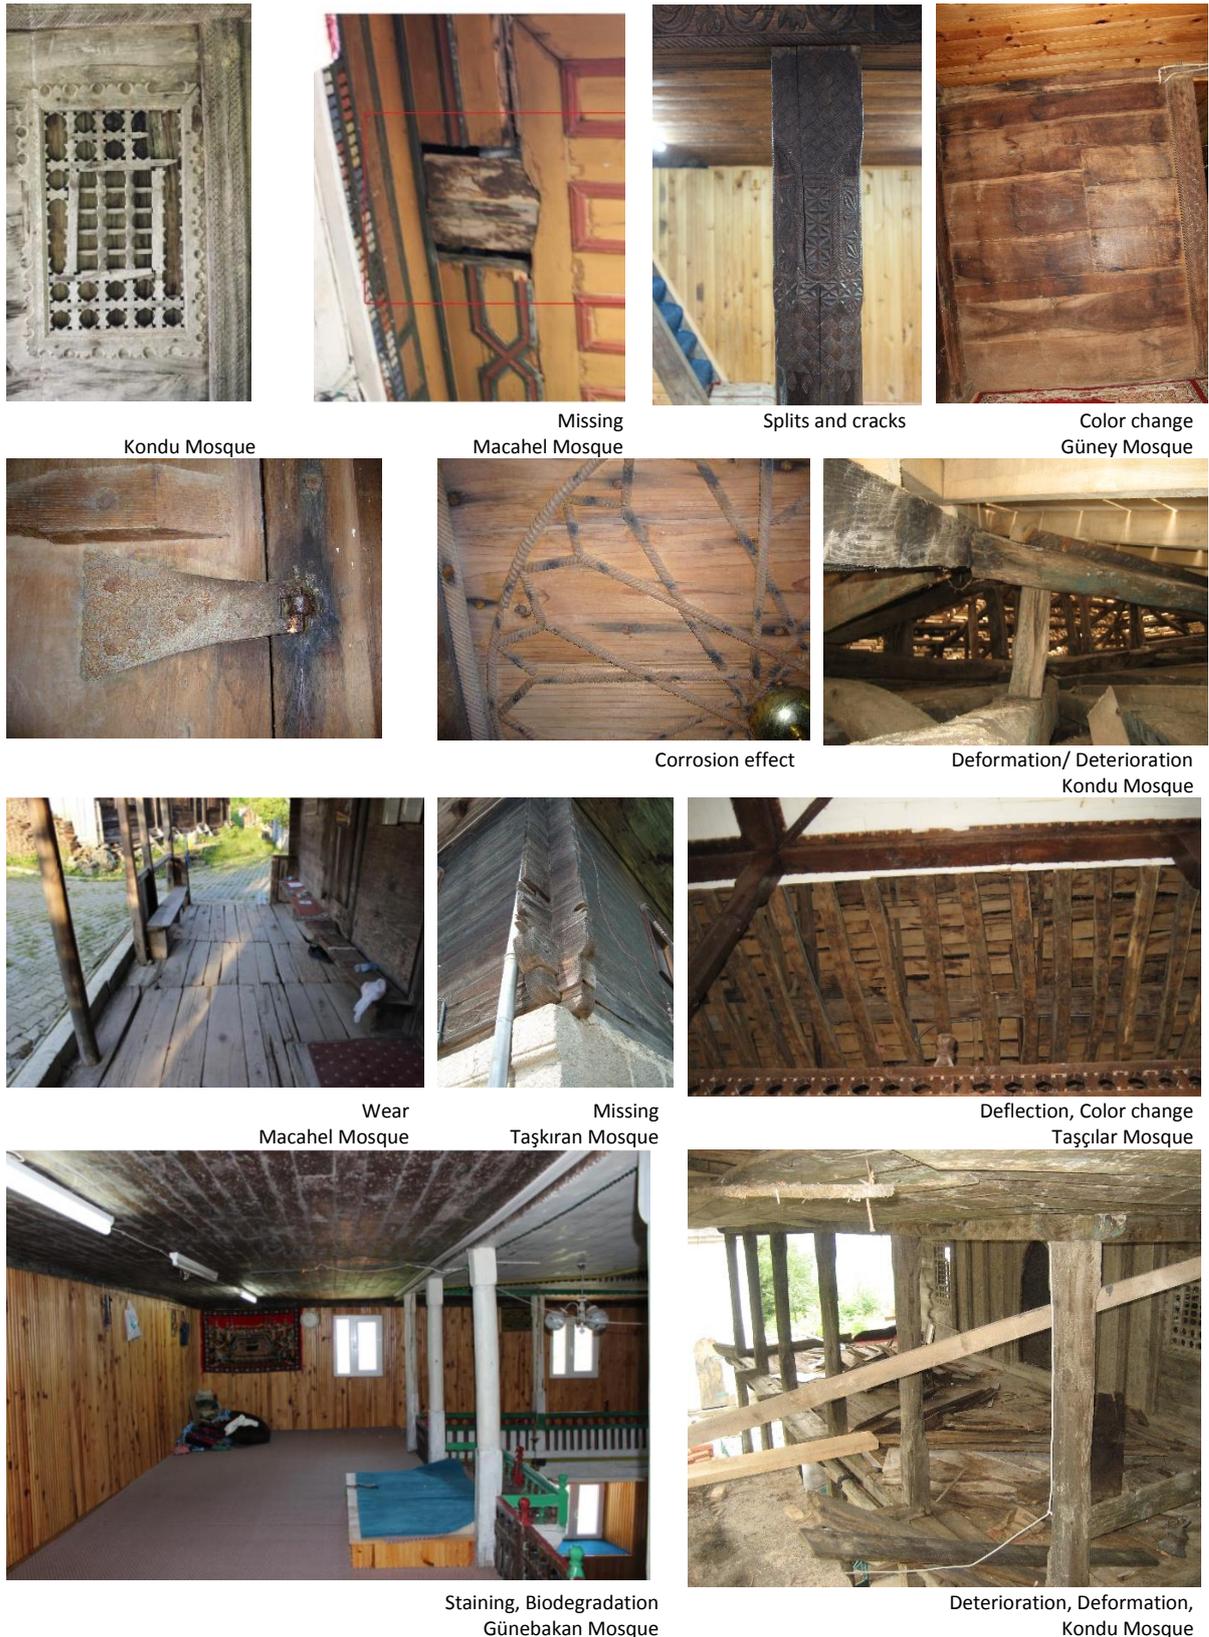
Another factor that causes damage to wood is bacteria and fungus in the environment. Bacteria, fungi and insects can be physically and biologically effective on wood material. They commonly cause increased water permeability of the material, decreased strength, and damage such as odour, deterioration, cracking, discoloration and staining. Insects also cause damage such as flying holes, insect galleries and dusting on wood (Peker, 2010; Tunca, 2019) (Figure 4) (Figure 5).

Figure 5. Examples of deformation in wood material originating from the environment in Wooden Mosques

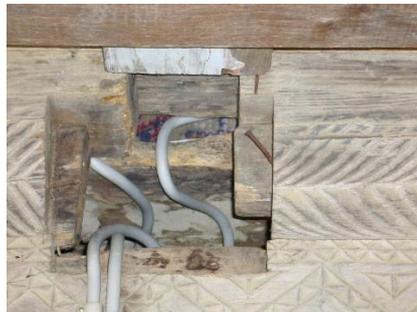
Plumbing system attachment
Kondu Mosque

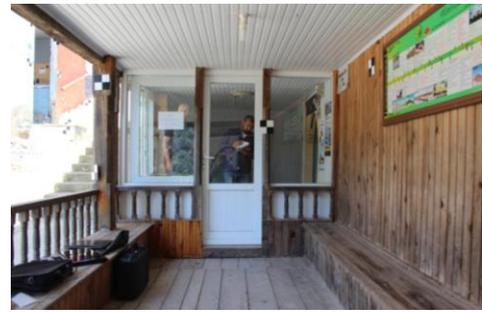
additional space, use of unqualified materials
Günebakan Mosque

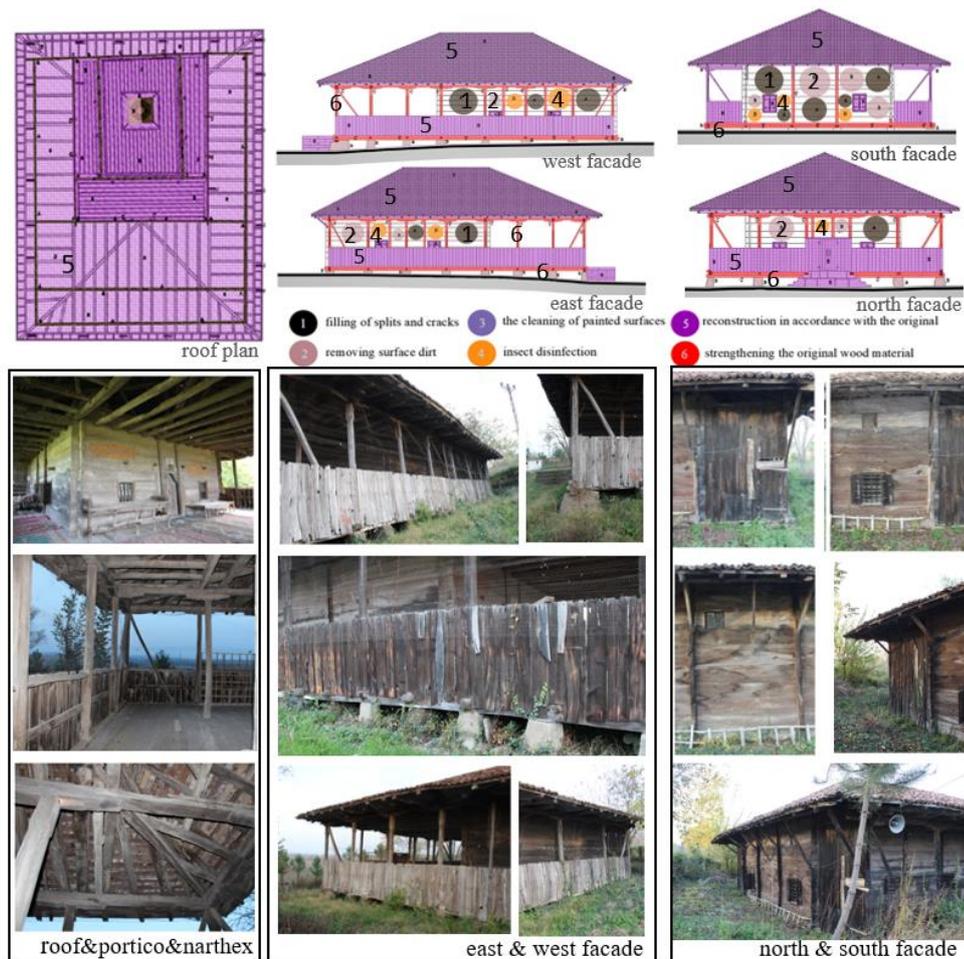
Figure 9. Deformations and interventions in wooden material in Ordu village mosque; roof, narthex, portico and façade

- The fact that the columns, railings and beams in the narthex and portico section are open to atmospheric factors caused the formation of holes, cracks and crevices in the material. Again, physical damage such as deterioration, wear and tear were observed in the exterior wall coverings and flooring in this section (Zan Mimarlık, 2015b). In the areas that were problematic in the protection process, the surface was cleaned, and holes, cracks and crevices were filled and strengthened in the wooden material in the first step. The areas with high deformation were renewed in line with the original.

- The wooden balustrades around the narthex and portico sections of the building were deformed due to atmospheric factors. The damaged wooden balustrades were rebuilt with hardwood in line with the original (Zan Mimarlık, 2015b). Again in this section, the openings covered with metal gauze were restored by removing the metal.

- On the south façade of the mosque, the southeastern and southwestern parts of the portico were covered with unqualified wood. The woods in this area were removed and the portico area was completed with wooden railings and supported with wooden studs.

- Various reductions and deformations have occurred on the window door in the building with the effect of time. The damaged, missing and broken wooden parts on the windows have been renewed. The south façade of the mosque has two window openings to the right and left of the mihrab. These two unqualified windows have been removed and their gaps closed. At the entrance to the sanctuary, the surface was cleaned, and the damaged and rotten parts were taken care of; holes, cracks, and crevices were filled and strengthened (Zan Architecture, 2015b).

- Widespread deformation was observed on the roof. As a general approach, the solid elements were preserved in the wooden roof, and the damaged ones were renewed.

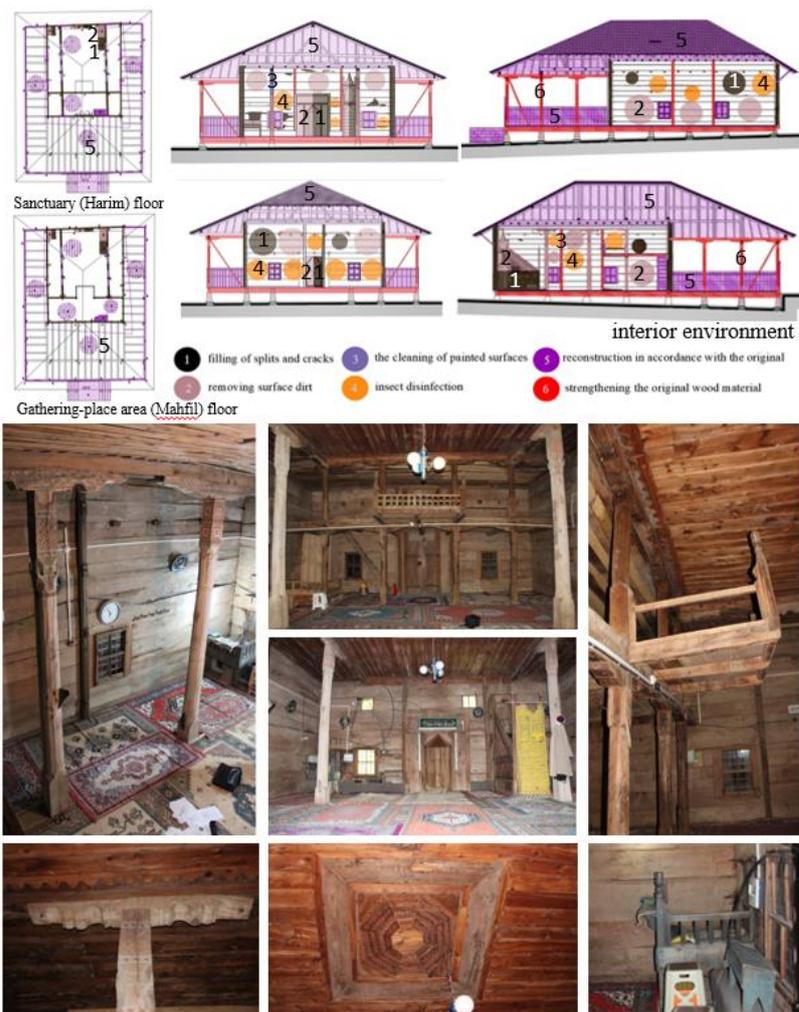
- Deformations and deterioration were observed on wooden walls, wooden columns and beams in the sanctuary and gathering place. Common contamination, loss-deformation and discoloration were observed on wooden surfaces indoors. The surface has been cleaned in the problematic areas, and holes, cracks and crevices have been filled and strengthened.

- Deformation and missing were observed in the wooden material in the core of the wooden ceiling. The damaged parts are refurbished from hardwood.
- Wood deterioration was common in the flooring in the sanctuary and gathering place. Corrosion was also found on the wooden staircase connecting the sanctuary and the gathering place. Problem areas on the floor and stairs were renewed with hardwood in line with the original.

- Physical destructions such as deterioration, wear and tear have occurred in elements such as the pulpit, mihrab and gathering-place kiosk, and lectern (Zan Mimarlık, 2015b). These items have been strengthened by cleaning the surface and filling holes, cracks and crevices.

- Missing and damaged sections were found on the railings on the gathering-place floor (Zan Mimarlık, 2015b). The railings were scraped and their damaged and missing parts were renewed.

Figure 10. Deformation and interventions in wooden material in Ordu village mosque; sanctuary, gathering place and wooden items

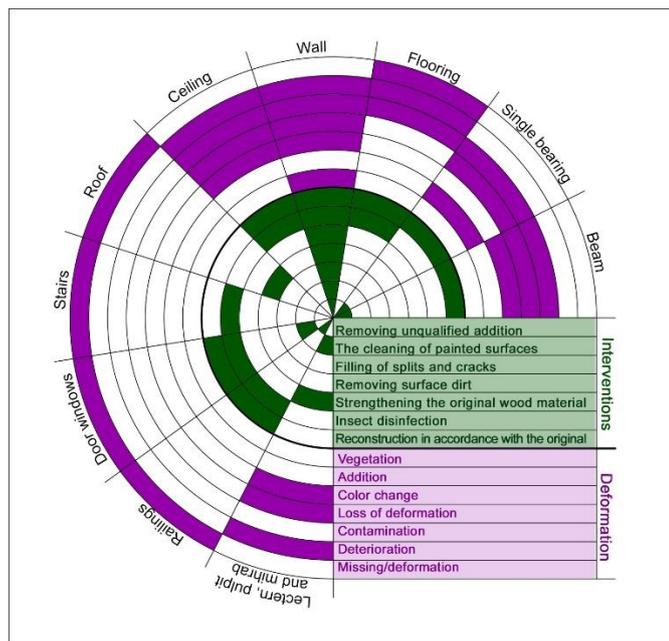
- 6 different types of wood damage were found on the wall element of the mosque. These are missing/deformation, contamination, addition, vegetation and deterioration in wooden elements. These problems were intervened in the form of strengthening the original wood, removing surface dirt and insect disinfection (spraying) and removing unqualified addition.

- Missing / deformation and deterioration were observed in the wooden elements of the flooring. For this, strengthening the original wood material, insect disinfection and reconstruction in accordance with the original were preferred.

- In the single bearing, contamination and deformation were observed in the wooden element. Here, the cleaning of surface dirt and painted surfaces and the strengthening of the original wood material were followed.

- Deterioration was observed in the beams and throughout the ceiling, as missing and deformation of the wood in the ceiling core. Filling of splits and cracks, strengthening of original wood, cleaning of surface dirt and insect disinfection were carried out.

- Deterioration in the stairs, door windows and railings, loss of deformation and vegetation in additions and materials were seen. On the roof, on the other hand, problems of losing strength have emerged. In these four areas, it has been tried to be reconstructed in accordance with the original.

- Filling the splits and cracks, cleaning the surface dirt and insect disinfection for the addition and contamination seen in the lectern, pulpit and mihrab in the building.

Figure 11. Deformation and interventions in wooden material in Ordu Mosque

Missing/deformation and deterioration of wooden material in the building are seen in points throughout the building and in larger areas in flooring. It is seen that the repair is based on the building in general, and the building element has been changed with the reconstruction in accordance with the original on the stairs, floor and roof.
