Environmental Corruptions on the Ancient Bricks of Kara Arslan Tomb in the City of Konya, Turkey

Abstract

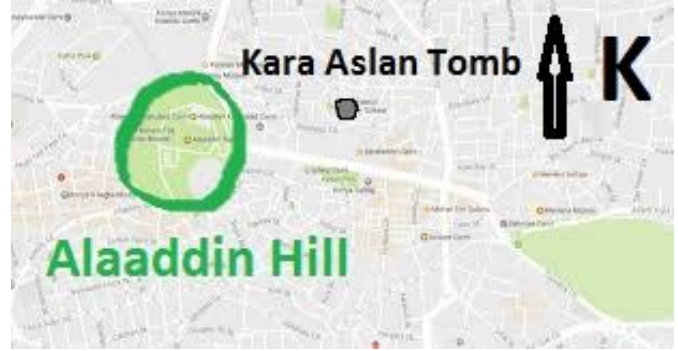
Figure 2. The location of Kara Arslan Tomb in Konya

The Kara Arslan Tomb, a XIII. Century monument of Seljuks, takes place at the city center of Konya at the eastern part of the Alaeddin Hill (Figure 2- Figure 3). Today, the restoration of this historical building is still continuing whose floor has been buried to the ground surrounded by tall buildings.

having been built with stone and brick during the Anatolian Seljuks Period (Figure 1). The foundations and the bodies of these monuments have been built with stone, and bricks have been used in the domes and vault sections of their constructions to cover their tops. Despite the backbreaking centuries, today these monuments are still alive and being restored against weathering due to environmental conditions. In this study, the damaged bricks that were pulled out during the restoration works of Konya Kara Arslan Tomb (a monument built in Anatolian Seljuks Period) were experimentally analyzed (Figure 2).

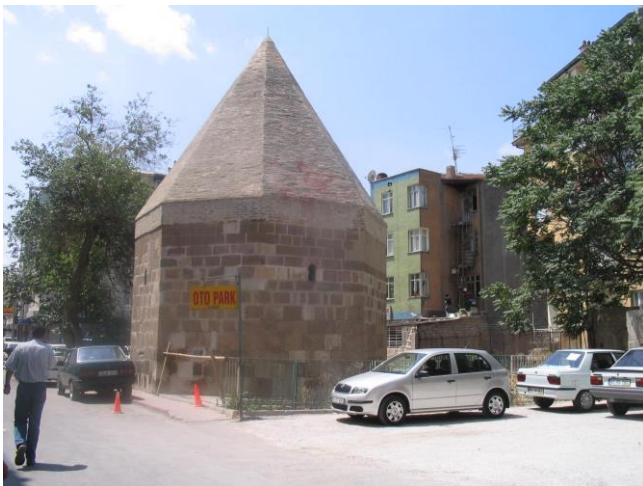
Figure 4. The historic building wall surface made by stone and brick material and belonging to Seljuk Empire

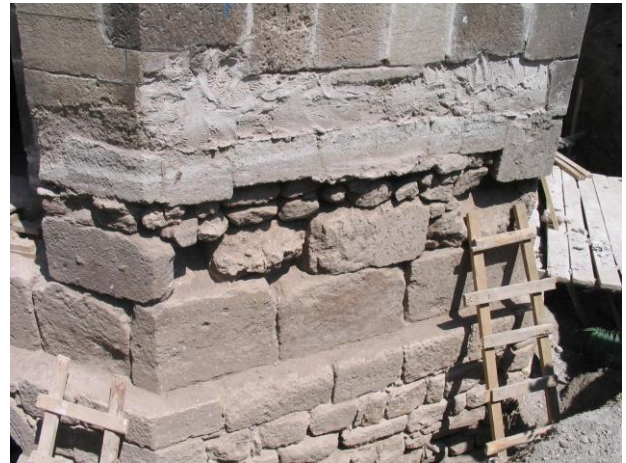
Figure 5. The historic building damaged wall surface made by bricks belonging to Seljuk Empire.

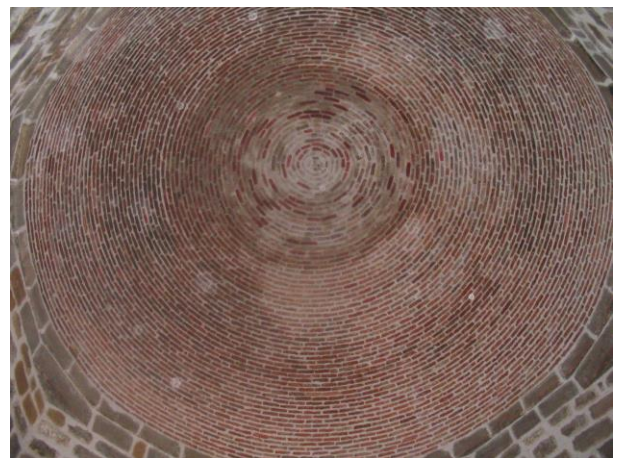
Figure 7. The dome sketch of Kara Arslan Tomb belonging to Seljuk Empire.

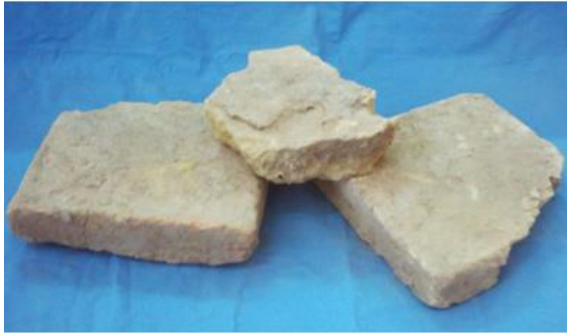
Figure 8. Ancient brick samples collected from Karaarslan Tomb.

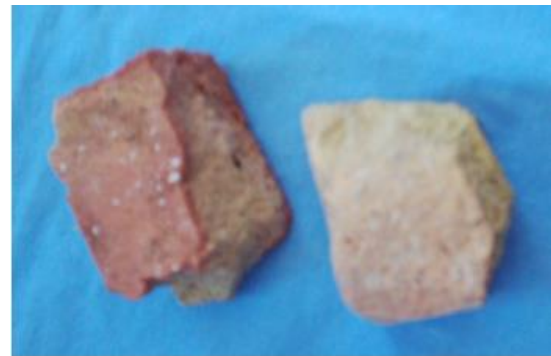
Figure 9. The efflorescence after bricks interaction with H₂SO solution.

The damaging effects of a certain chemical solution, namely sulphuric acid (H₂SO₄), on the characteristics of the sample bricks were analyzed by making a series of experiments during which the chemical concentration of this acid solution was constant with 3% value. The general view of a typical masonry surface exposed to acid solution is given in Table 3. The tests of acid solution attack continued up to the 21st day when the slight weight loss was observed. The weight loss values of the wetting-drying cycles were respectively recorded at 3rd, 6th, 9th, 12th, 15th, 18th and 21st days. The damaging effects of the solutions were considerably related with the wetting-drying cycles at the masonry face. The chemical attack experimentally analyzed for the ancient bricks first starts from the face of the brick and continues through its pores (Figure 9) due to the porous structure of the bricks absorbing the chemical solution with various amounts. The weight loss values of the ancient bricks in 3% chemical solution in a 21 day period are given in Table 3. The maximum weight loss of 44.25% was obtained for the bricks immersed in 3% sulphuric acid solution for 28 days.

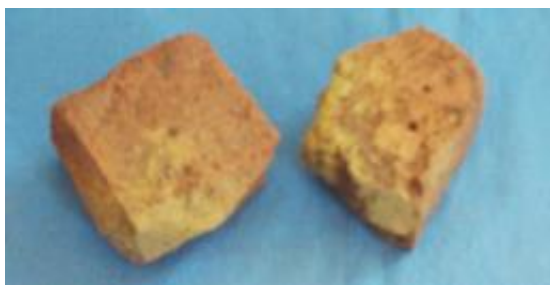
Figure 10. Appearance of the brick sample after Na₂SO₄ solution attack.

days until the slight weight loss increase was experienced (Figure 10). The weight loss values of the wetting and drying cycles were respectively recorded at 3rd, 6th, 9th, 12th, 15th, 18th and 21st days (Table 4). Bricks have the ability of losing weight and the tests with the sodium sulphate immersion presented that the weight loss of the samples was about 39.87%. In some pores, it was observed that salt crystals occurred at the sides as viscous crust rounds. After drying the brick sample, the soluble salt crystals affecting the capillary action, viscosity, permeability and moisture diffusivity of the material were still remaining in the pores. The formation of the salt crystallization action in the brick samples was recorded in every step of the drying-wetting cycles. In this context, the damaging effects of both sulfate solutions were experienced in terms of weakening the brick samples.

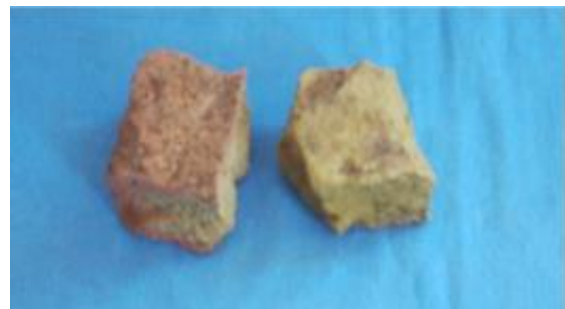
Figure 11. Appearance of the brick sample in relation to NaCl solution.

The damaging effects of the bricks due to salt solutions were also determined by making experiments with 3% NaCl salt solution. The samples were subjected to wetting and drying cycles by the capillary action in 3% NaCl salt solution for 21 days (Figure 11). The test results are given in Table 5. As it was experienced before for the sulfate solutions, the efflorescence of each

brick sample occurred with crusty white crystals existing at 5-8 mm depths from the surfaces in the 3% NaCl solution. However, this situation may be relatively harmless compared to hidden salt crystallization. At the end, the deterioration was measured by making weight loss evaluation after the solution attack which was found to be 42.35% against the sodium chloride solution effect.
