Wood Damages and Improvement in Rural Mosques: Ordu Mosque

Şengül YALÇINKAYA ^{1*}

Citation: Yalçinkaya, Ş. (2023). Wood damages and improvement in rural mosques: Ordu Mosque. *Journal of Architectural Sciences and Applications*, 8 (1), 100-111.

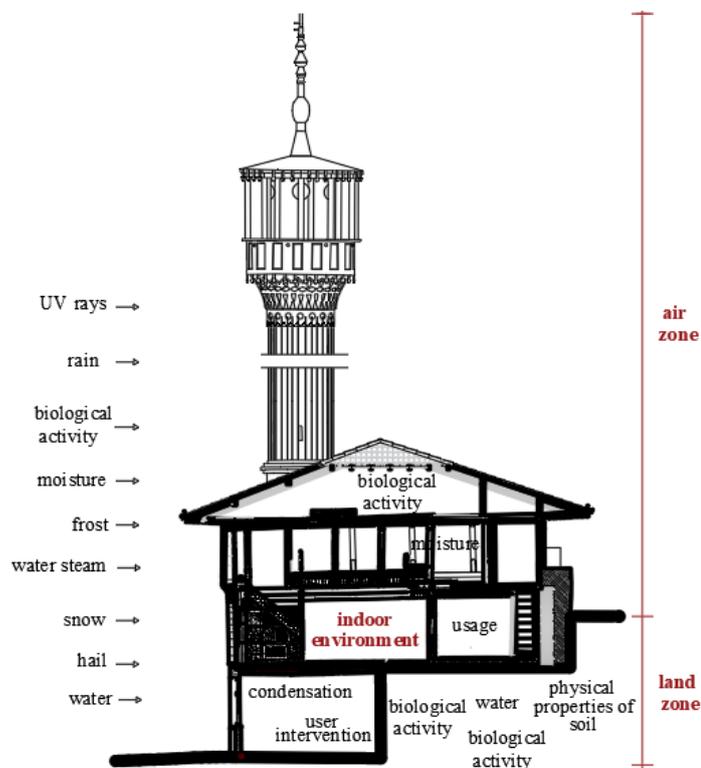
Another factor that causes damage to wood is bacteria and fungus in the environment. Bacteria, fungi and insects can be physically and biologically effective on wood material. They commonly cause increased water permeability of the material, decreased strength, and damage such as odour, deterioration, cracking, discoloration and staining. Insects also cause damage such as flying holes, insect galleries and dusting on wood (Peker, 2010; Tunca, 2019) (Figure 4) (Figure 5).

Figure 4. Factors causing deterioration of wood material
